Online Leak Sealing

20" x 4" Tee Repair

North Sea Operator

Oil Platform, UKCS

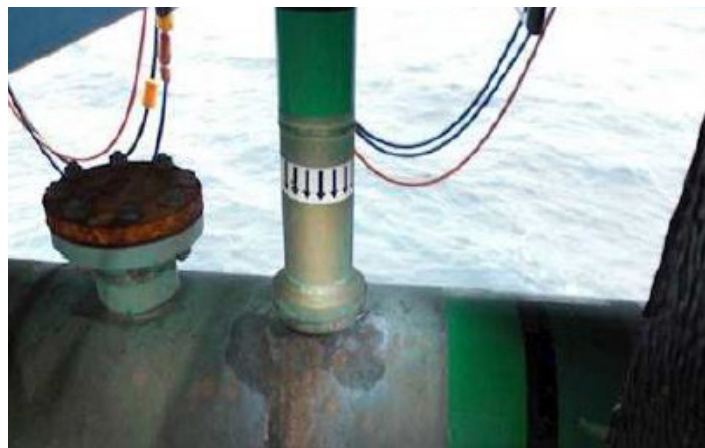
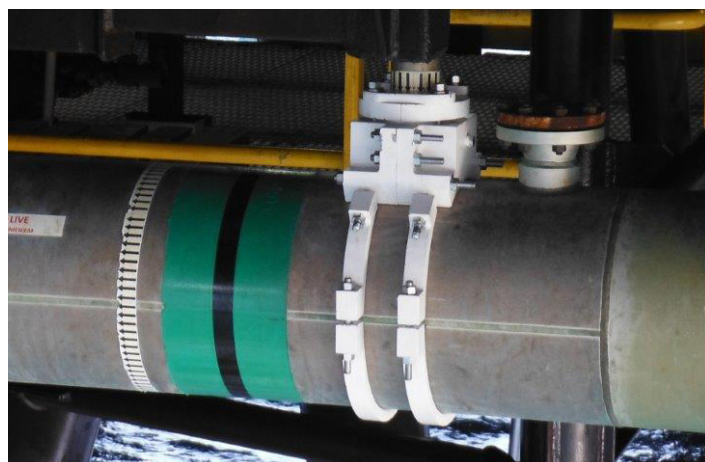
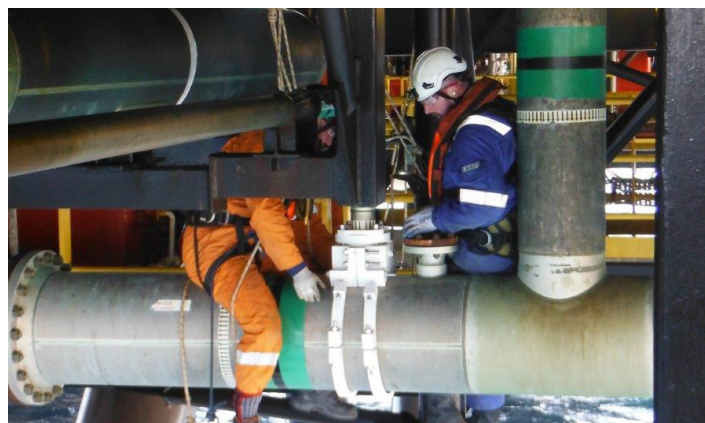
The client approached ICR to seek a solution to encapsulate and seal the leaking defect whilst reinstating integrity to the pipework. The repair involved a 20" NB pipe with a 4" NB branch with a weld defect where the branch pipe joined to the main header causing a seawater leak with the risk of structural failure of the joint.

ICR designed and manufactured a mechanical repair clamp to enclose the defective weld. This provided full pressure containment of the leaking line content and reinstated full structural integrity to the pipework.

The main body of the repair clamp is split into two sections, allowing it to be bolted around the defective branch pipe and featured restraints to ensure the 4in NB could not become detached from the 20" header.

The repair utilised an elastomeric seal system, energised around the 20" NB main header pipe, the sealing boundary then runs around the joint face of the split clamp before sealing around the circumference of the branch pipe.

A two-part marine epoxy coating applied externally and internally to the clamp protects the repair from exposure to the marine environment. With the clamp also needing to be installed by ICR rope access specialist, the clamp was designed to keep the weight of the individual components to a minimum with features to ensure the repair could be installed as safely and easily as possible.
