Online Leak Sealing

3" NB Pipe Repair

North Sea Oil Platform

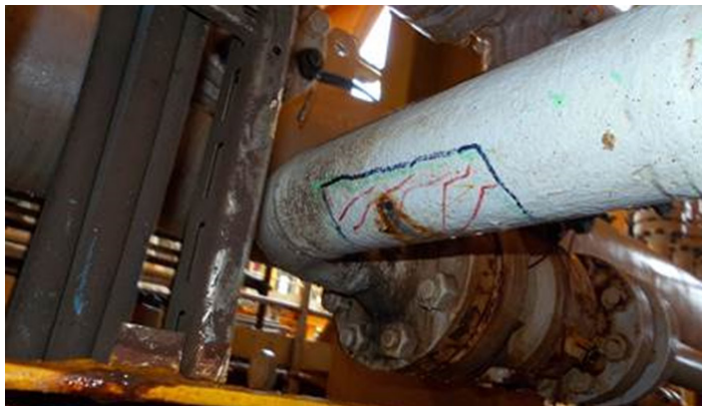
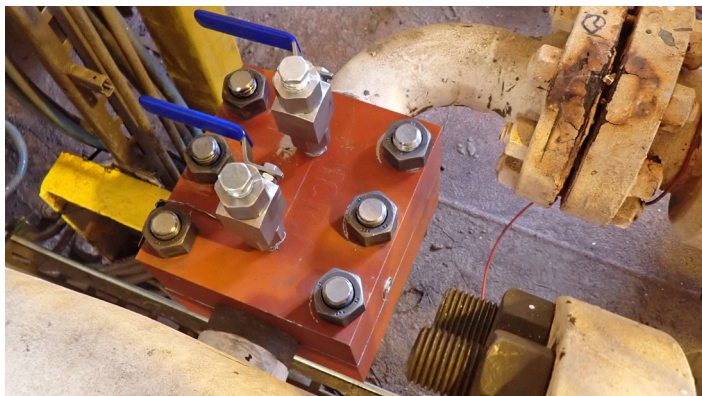
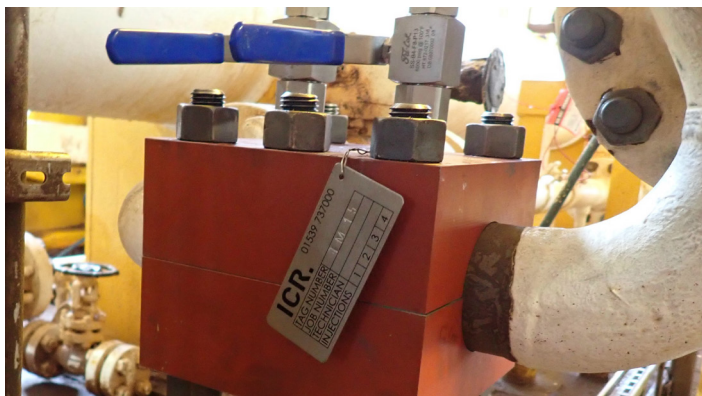
A through wall defect with a hydrocarbon leak on a 3 in NB pipe on an offshore platform export piping system causing a shut down.

A composite repair was considered and discounted in favour of a mechanical repair clamp to enclose the defect. The repair clamp was designed to provide full pressure containment of the leaking line contents.

The repair clamp utilised a single elastomeric seal system energised around pipe, the sealing boundary then runs around the joint face of the split clamp sealing around the circumference of the pipe. The main cavity of the clamp was injected with a two part high density flexible sealant.
