Integrity Monitoring

Identifying Faults with Electrical Boards Offshore

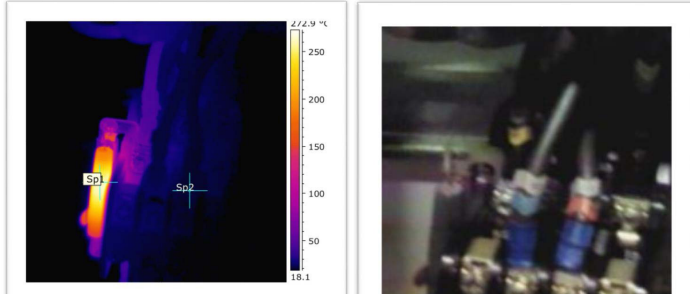
Resistor displaying temperature of 250 degrees which is significantly above ambient and operating temperature. This was classed as a serious priority.

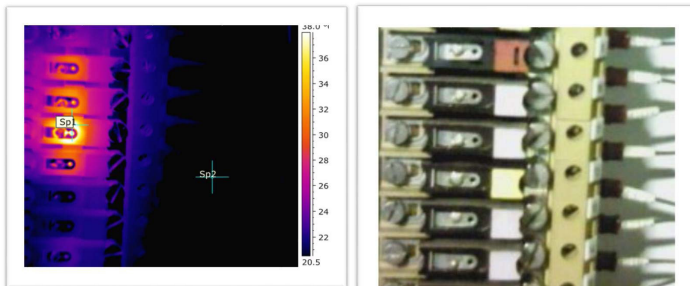
Fuse displaying temperature of 20 degrees above ambient and operating temperature.

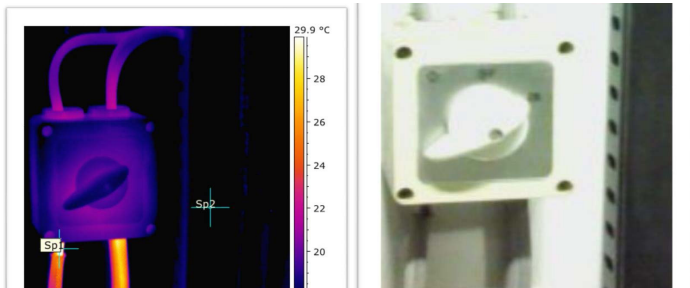
Cables from main isolator switch displaying temperature of 15 degrees above ambient and operating temperature. There is also damage noted to one of the cables.
