Integrity Monitoring

Repair Of Seized & Damaged Corrosion Monitoring Access Fitting

August 2021

Southern North Sea

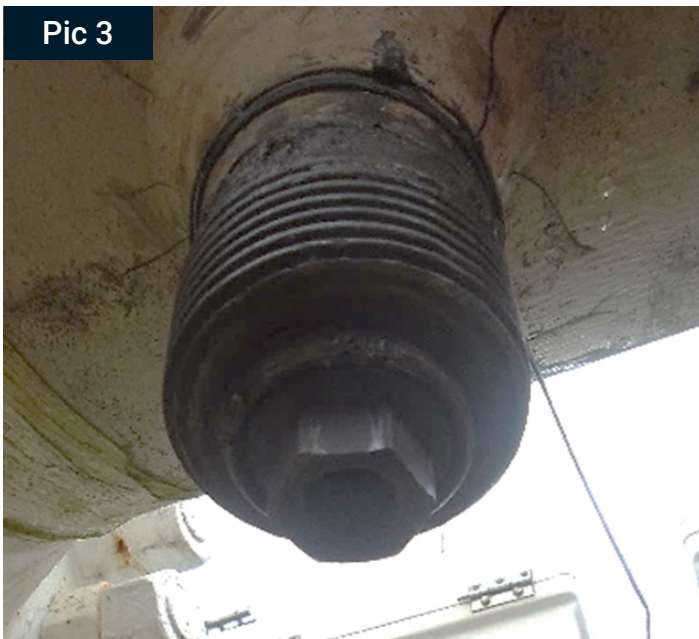
- ICR were able to remove the seized carrier plug safely without causing any further damage to the access fitting
- A new carrier plug was fully installed (Pic 3, left) along with a new heavy duty cover
- A leak test was then conducted to confirm a seal and that the integrity of the line had been restored (Pic 4, below)
