## Technowrap™ Engineered Composite Repairs

# 2K HA - 30" Crude Oil Leaking Clamp

April 2018

Abdali Main Point – Abdali Mid Point, Kuwait

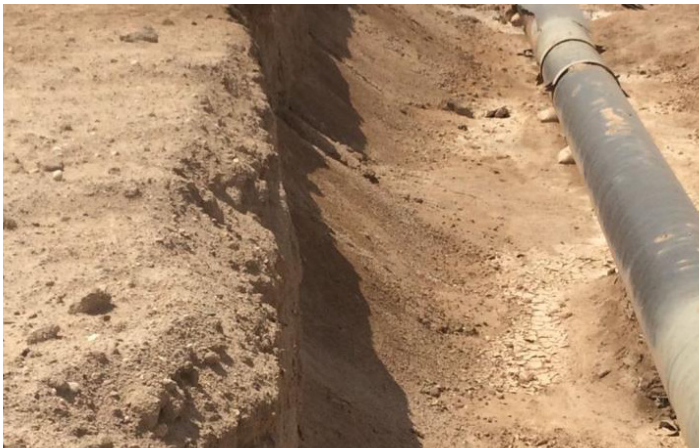
Excavated ground revealing buried pipework

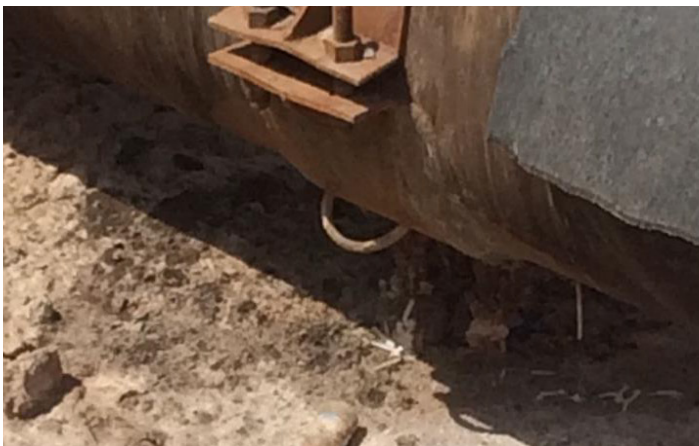
A 30" Crude Oil Pipeline had suffered a through-wall defect previously. A clamp was the initial preferred method of repair, however this had failed and was actively leaking. ICR were tasked to provide a solution to repair the leaking clamp whilst the line was still live and the leak still active.

Live leaking defect found at the 6 o'clock position

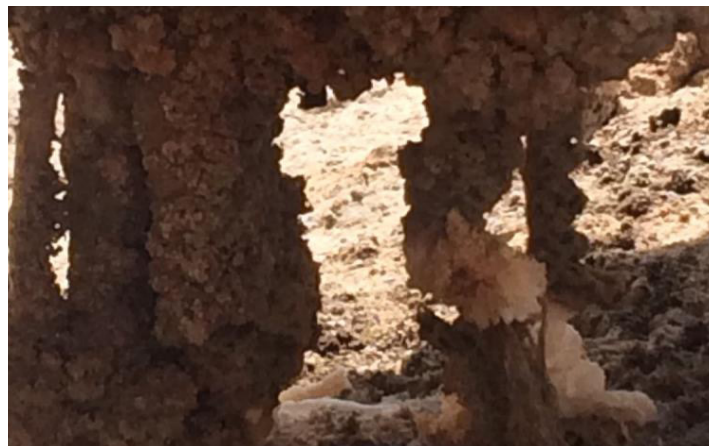
Large build up of scaling on underside of pipework

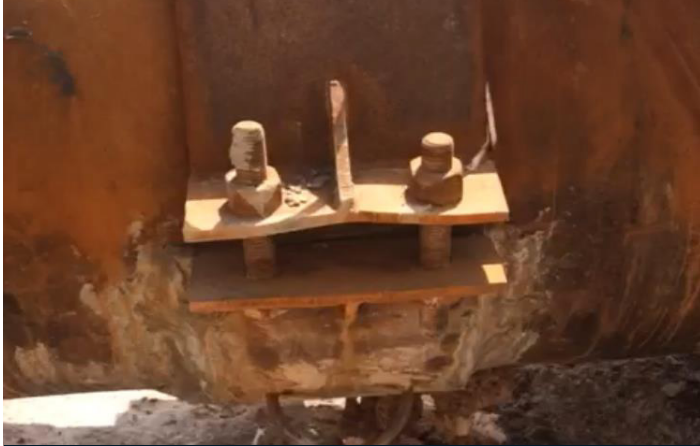
Clamp requiring profiling using Technoseal FP
