Technowrap™ Engineered Composite Repairs - 2K LT Pipework Emergency Repair

UK Medical Products Supply Company

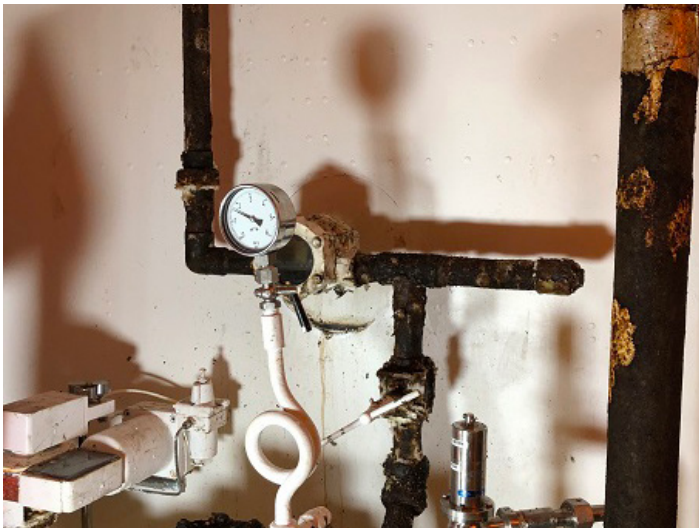
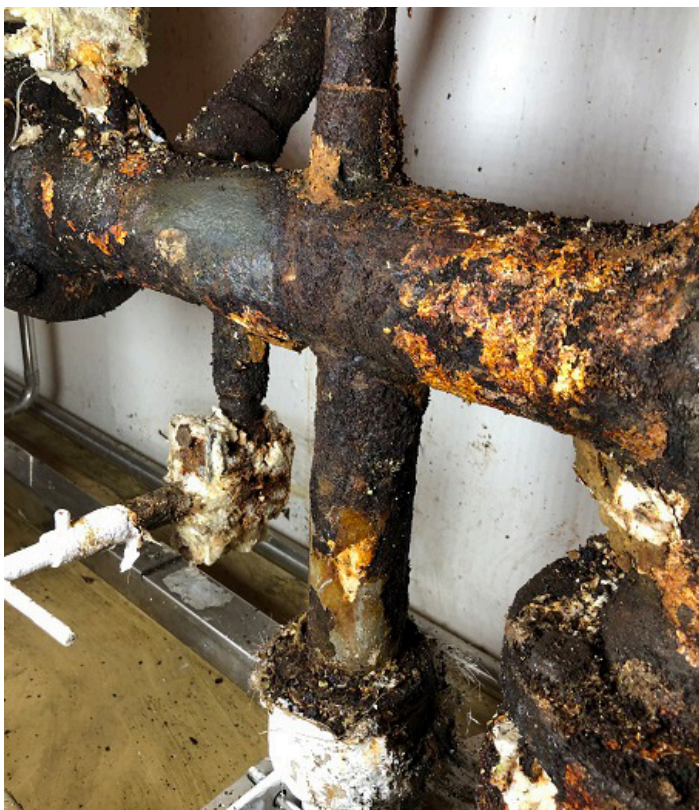
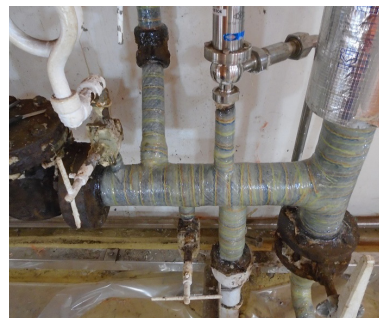
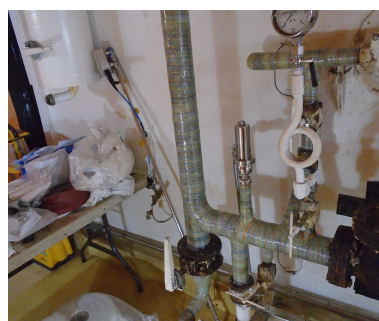
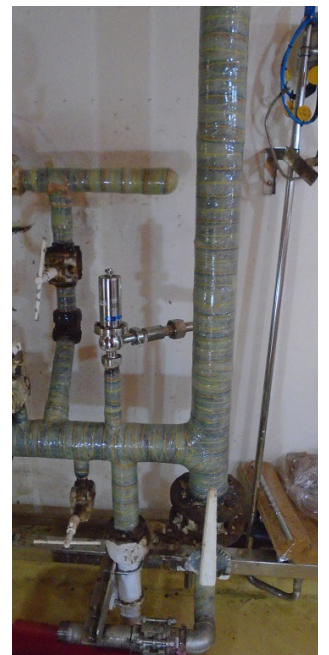
On removal of insulation during plant shutdown, severe external corrosion under insulation was found on an approx. 3m length of 2" to 4" diameter water/ethanol pipework between valves and branches. ICR were approached to propose a solution to restore the integrity of the pipework and allow the plant to be rapidly returned to service. The repair design conditions being 2.5barg pressure, ambient/-35°C temperature with 2 year design life.

A Technowrap™ 2K LT engineered composite repair solution was proposed with surface preparation by hand to minimise chance of pipework going through wall. ICR mobilised technicians and material to site. During the repair, additional pipe sections were found to be corroded and repair scope doubled. ICR provided additional materials and technicians with night shift established to enable repairs to be completed to the required schedule. From initial approach to the repairs (including additional scope) being completed and signed off, was just over a week.

- Pipework integrity restored
- No through wall penetration during repair
- ICR technicians worked day and night to complete the repair with increased scope allowing the plant to return to service in line with schedule
