Integrity Monitoring

Thermographic Inspection of Platform Exhaust Stacks

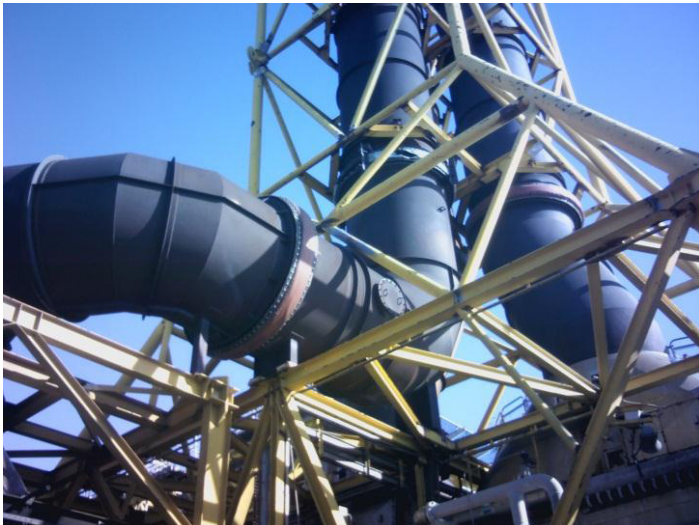
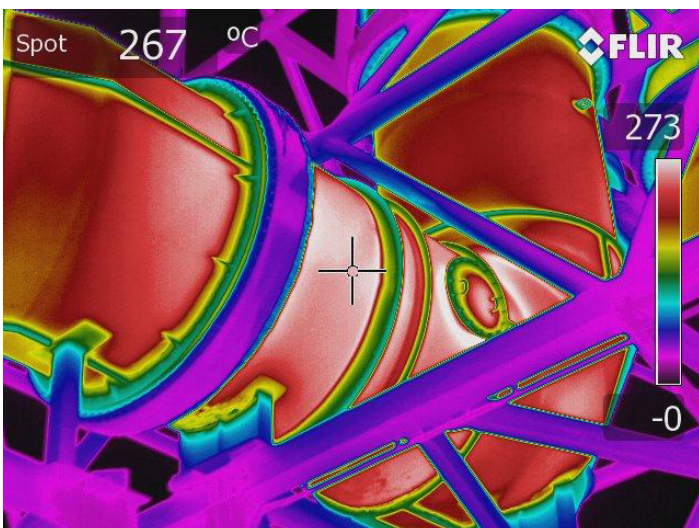
- Inspection showed that the carbon steel exhaust ducting appeared to be in good condition with no signs of cracking or porosity. The flexible flanged area on the horizontal section of stack was found to be in poor condition.
- The structural support beams were also found to be in good condition with heat sources discovered on the section closest to the stacks. This is thought to be due to coating deterioration.
