Structural repair of bridge link beams in the Dutch North Sea

Date: May 2023

Location: Dutch North Sea

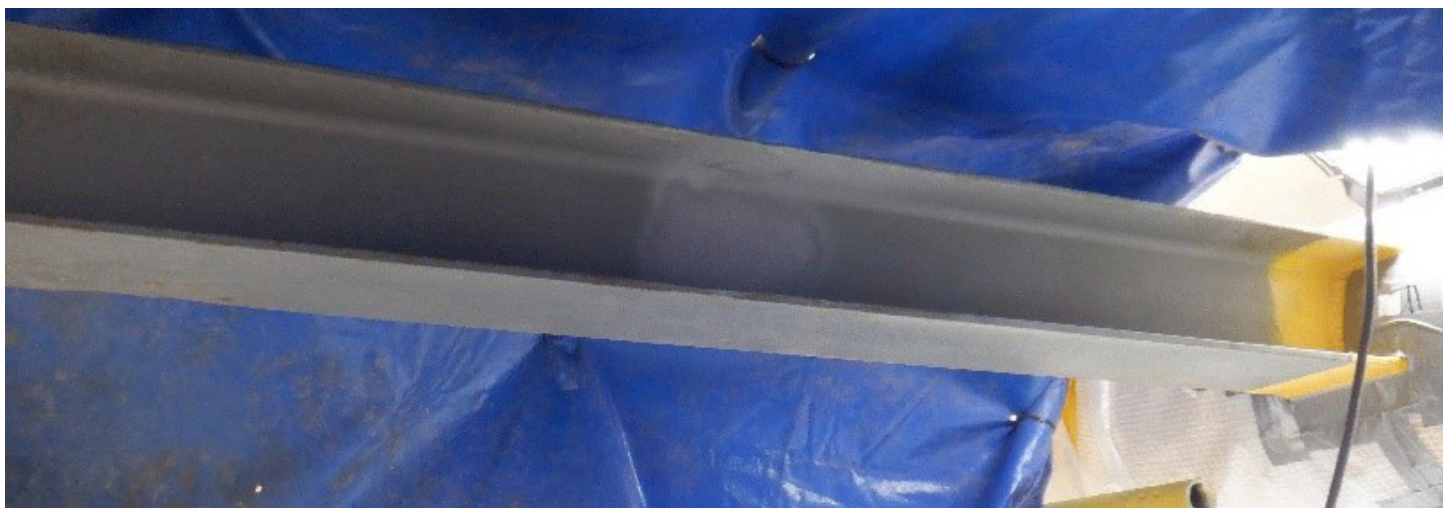
Assessment and preparation: The bridge link beams were thoroughly assessed to identify the extent of corrosion and damage. The corroded areas were cleaned and prepared for the application of the composite repair system.

Beam after surface preparation, ready for composite repair.

Fabric selection and laminate formation: Technowrap™ SRS and Technowrap™ HPPRS fabrics were selected based on their individual strengths and characteristics. A customised laminate was created, leveraging the unique properties of each fabric to achieve optimal strength in the correct load path.

Application: A supervisor and two technicians were deployed to carry out the repair. The laminate system was applied to the bridge link beams, ensuring full coverage and conformity to the complex geometries of the structures. The installation process required no fabrication, hot work, or heavy lifting, streamlining the repair and minimising downtime.
