Case study

## Preserving integrity: structural repair of I-beam walkway supports

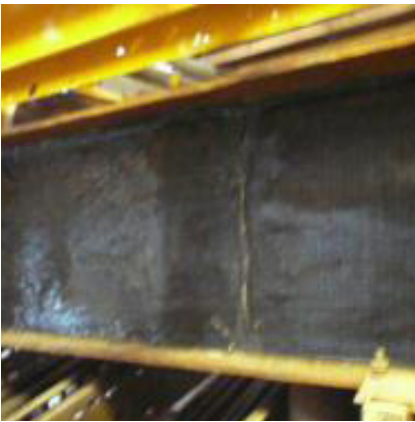
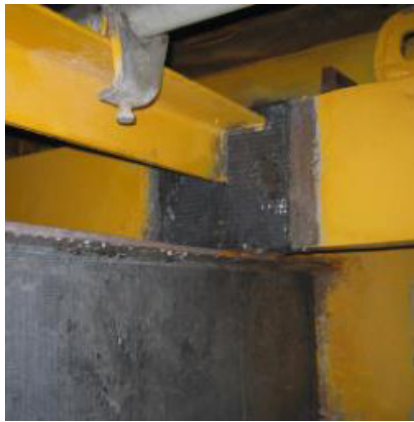
*Walkway beams after repair*

A Technowrap™ carbon fibre structural solution was successfully applied to the external surfaces of the supports, reinstating the integrity of the structure and the repairs were
