# STRUCTURAL REPAIR

## VIBRATION INDUCED FATIGUE FAILURE

MAJOR GLOBAL OPERATOR

NOVEMBER 2019

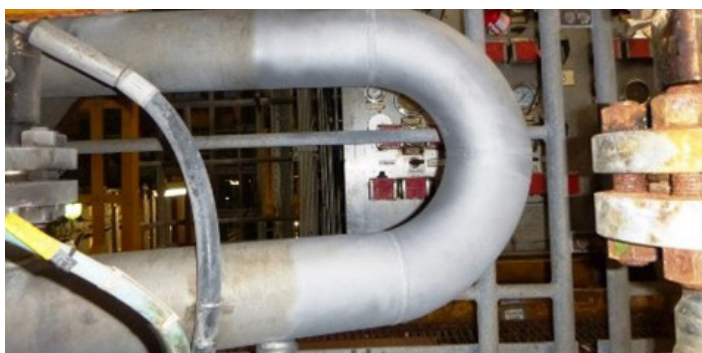
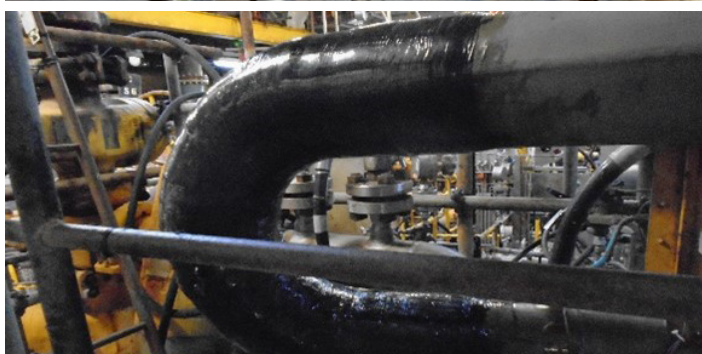
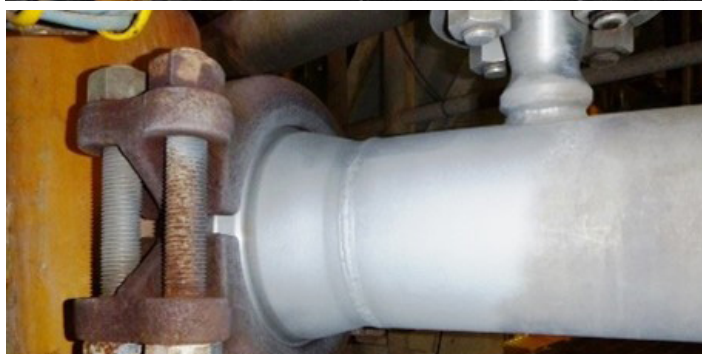
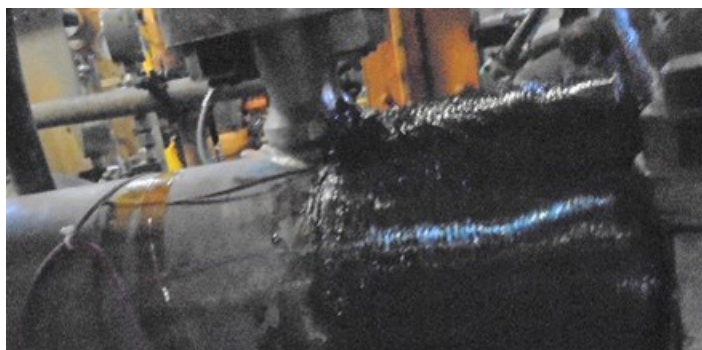
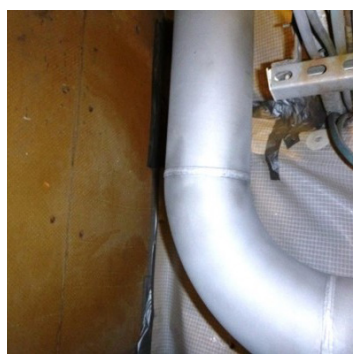
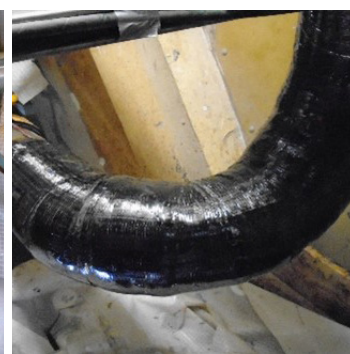
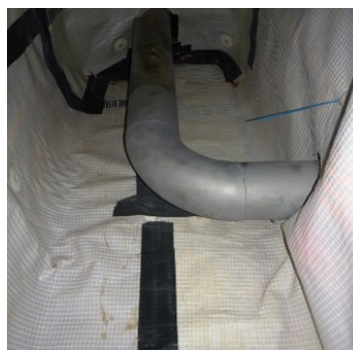
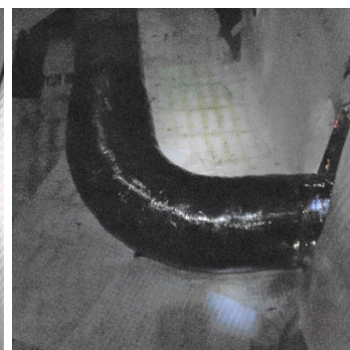
An investigation on board a north sea platform was carried out on a 6" super duplex line that was suffering from vibration. It was determined that the welds in four separate locations would fail due to fatigue. The client approached ICR looking for a repair solution to stiffen the four areas where there were concern of fatigue failure. In order to achieve direct measurement of the stresses around the welds, strain gauges were utilised before and after installation and as a precautionary measure to verify the carbon fibre repairs installed would sufficiently stiffen the areas.

ICR completed engineered designs for each repair using design conditions supplied by the client which incorporated internal pressure, axial loads, torsion and bending moments. Varying layers of Technowrap SRS (Structural Rehabilitation System) and HT (high temperature) resin depending on the design considerations.

Measurement using strain gauges following installation concluded that the composite repairs successfully stiffened the fatigued welds mitigating any future concern of failure and providing a design life of 14 years.
