Technowrap™ Engineered Composite Repairs  
2K HT - Caisson Corrosion Protection

**Date**  
August, 2019  
**Client**  
Major North Sea Operator  
**Location**  
Onshore Aberdeen

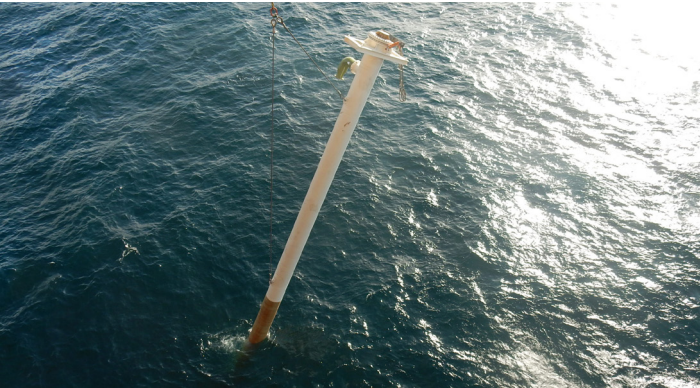
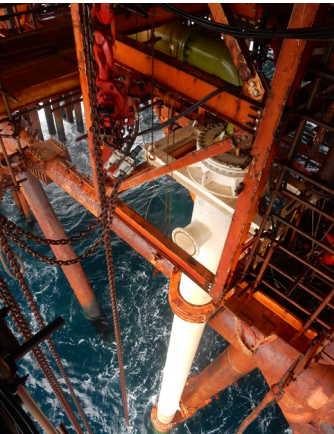
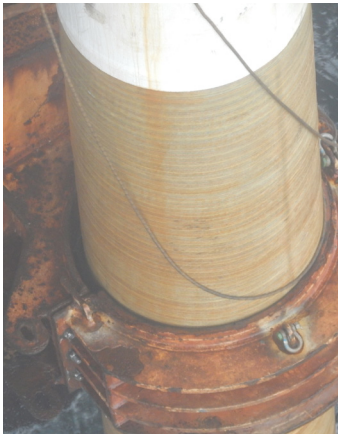
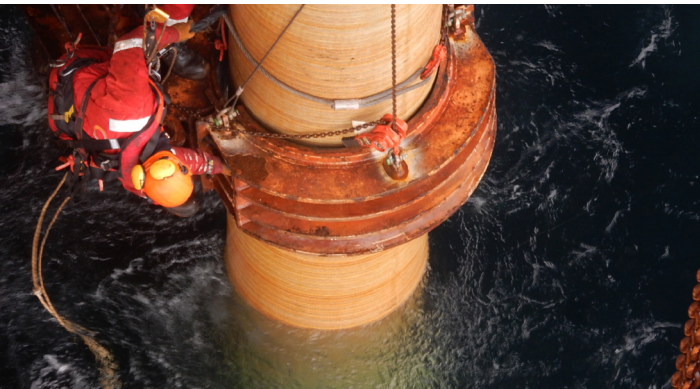
ICR were engaged to provide a engineered composite repair solution on a produced water caisson prior to installation offshore. The previous caisson was corroded due to wave action causing thermal cycling.

Two new sections of a 12" caisson were fabricated and sprayed with an internal coating prior to ICR applying the composite solution. It was a design requirement that surface preparation to Sa2.5 and was achieved prior to the application of 4 layers of Technowrap™ 2K using HT (High Teemperature) resin.

These were then welded together and an angular profile of 45μ was achieved using bristle blasters. A composite wrap was then applied to cover the welded section. Heat blankets were used throughtout the process to assist curing.

The change in temperature was taken into consideration by derating the allowable strains in line with ISO 24817.
