## Technowrap™ Engineered Composite Repairs SRS - Stair Tower Repair

**Date**  
2017  
**Client**  
Major North Sea Operator  
**Location**  
UK North Sea

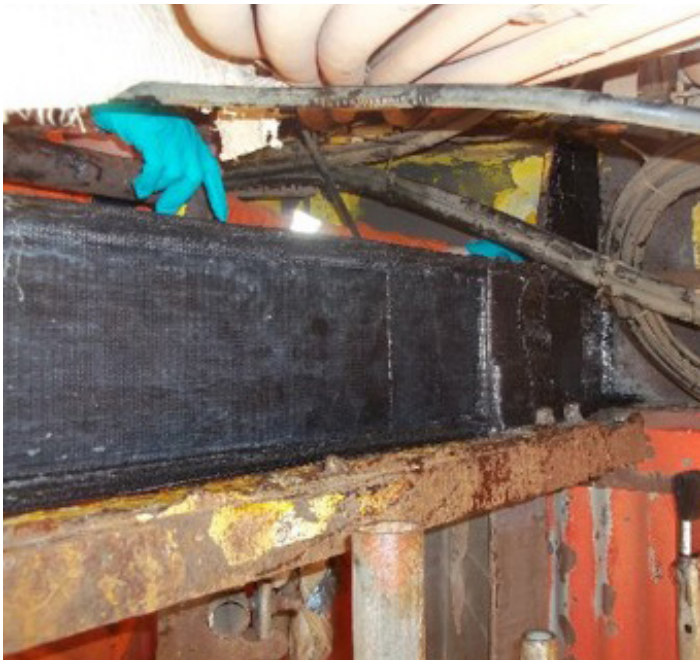
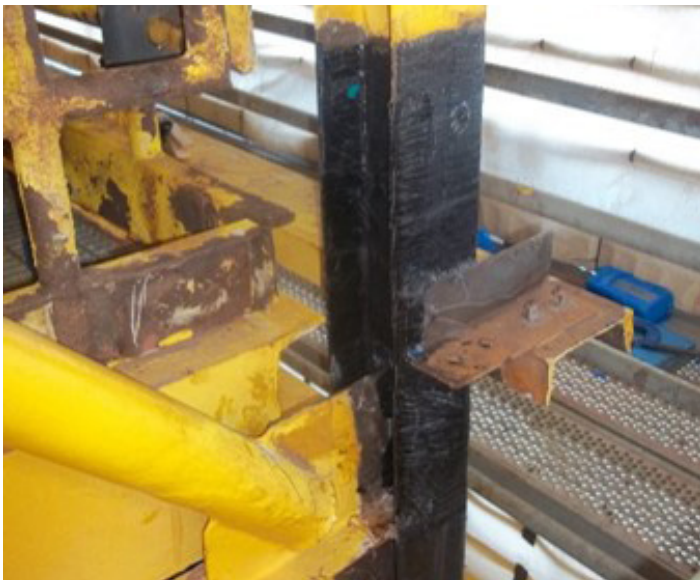
The stair tower on large North Sea platform was out of use due to heavy corrosion on the structural members. The operator contracted ICR to deliver a cost effective option to re-instate the stairwell to its original design capacity. Phase 1 took place in July 2017 whereby work commenced on the lower section of the stair tower with approx. 80 metres of beams and tubulars being repaired. Phase 2 began in August 2017 to repair the upper section of the stairwell.

Technowrap™ SRS - ICR's structural carbon fibre repair system - was recommended to provide added toughness. A low temperature curing resin was used and designed to suit ambient conditions in the North Sea.

The client provided a surface profile of SA2.5 (grit blasting). Complexity of the scope required maximum efficiency from the onboard fabric maintenance (FM) team and prior to mobilisation, ICR trained the FM crew on the application of gel coating. This was applied within 4 hours of blasting in order to hold the blast and prevent gingering. A team of four ICR technicians worked back to back within a double skin habitat to maintain a suitable environment. Materials were prepped and ready for the next shift to ensure optimum productivity on the job.
