Technowrap™ Engineered Composite Repairs

Splashzone - 48" Caisson With Live Leaks

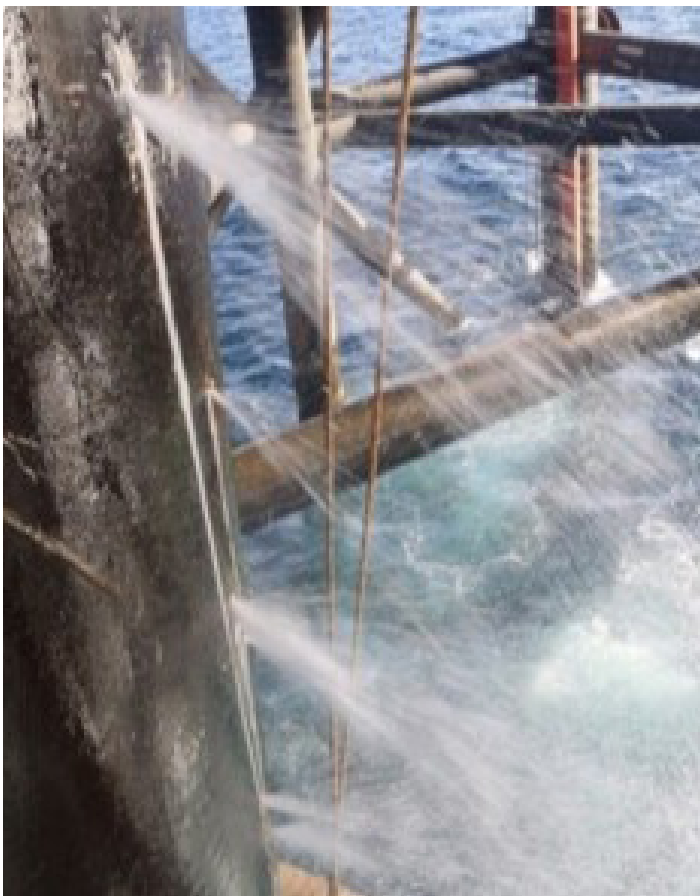
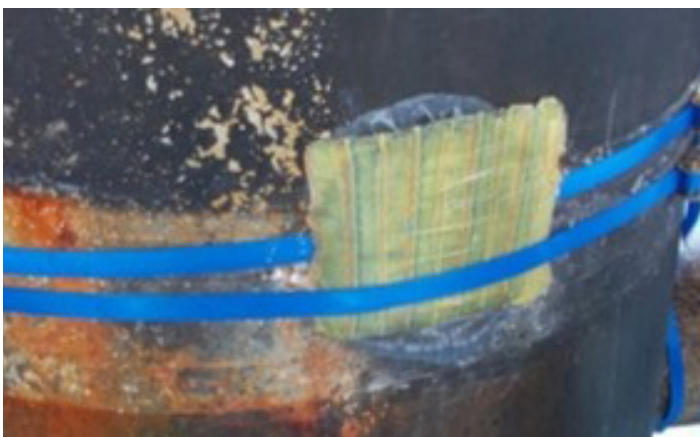
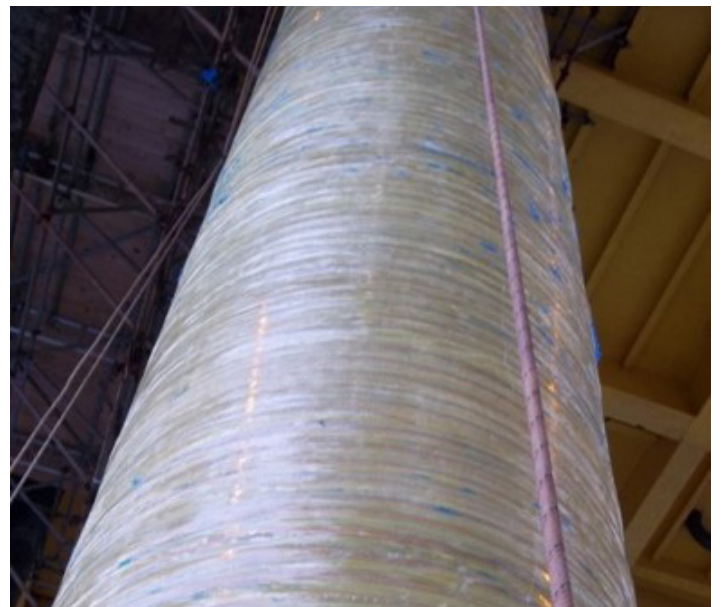
A 48" discharge caisson had a large number of through-wall defects over a vertical length of 23 meters that required immediate attention. The scope of the work was to provide an engineered design, with 20 years repair lifetime. This required live leak sealing the numerous through-wall defects and applying both Technowrap™ 2K and Technowrap™ SRS over the defect areas.

The Technowrap™ 2K and Technowrap™ SRS repair using ICR's Splashzone™ resin system was installed live.

The combination of the two repair products was a requirement to withstand both the internal pressure plus the axial bending moment resulting from the wave loading. Having successfully overcome all challenges, ICR's composite engineering team was able to successfully complete the repair of length 23 meters on the 48" caisson. All 40 plus through-wall defects were successfully sealed and the structural integrity of the caisson was reinstated for an extended lifetime of 20 years.

- All 40 plus through-wall defects were successfully sealed and the structural integrity of the caisson was reinstated for an extended lifetime of 20 years
- Applying the repair live resulted in zero impact on production and operations to the client and providing an extremely cost effective solution
