Integrity Monitoring

Repair Of Seized & Damaged Corrosion Monitoring Access Fitting

August 2021

Southern North Sea

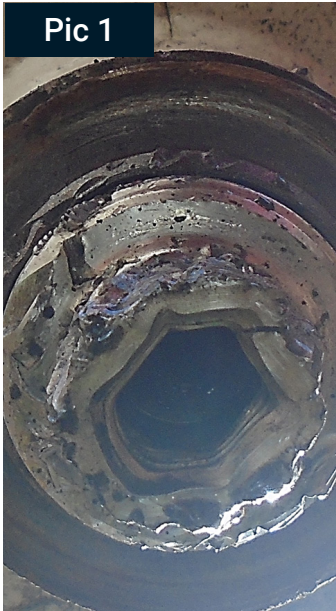
ICR were requested to service and refurbish a number of access fittings during the platform shutdown. These access fittings were in poor condition and, for some, the historical service history was not known. When servicing the import flowline location the internal carrier plug was found to be seized half way in the fitting and attempts to remove (by the previous service company) had resulted in significant damage to the plug (Pic 1, left). The carrier plug would not have been holding pressure and the only historical isolation on this line was provided by the heavy duty cover. The line could not restart until the issue was rectified.

ICR mobilised an on-site machining technician and specialist drilling equipment. The drilling equipment is designed specifically to remove seized carrier plugs from access fittings. It uses a hollow cutter which allows the carrier plug threads to be removed without damaging the internal threads of the access fitting (Pic 2, left). This allows the remaining plug section to be removed before the internal threads are tapped and a new carrier plug installed.
