Integrity Monitoring

Thermographic Inspection of Platform Exhaust Stacks

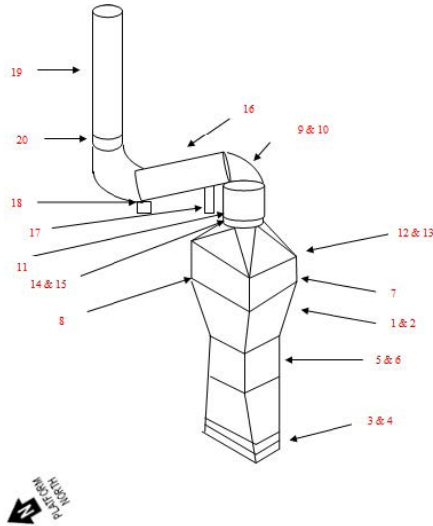
- Inspection showed that the carbon steel exhaust ducting appeared to be in good condition with no signs of cracking or porosity. The flexible flanged area on the horizontal section of stack was found to be in poor condition.
- The structural support beams were also found to be in good condition with heat sources discovered on the section closest to the stacks. This is thought to be due to coating deterioration.
