## Online Leak Sealing

# Complex Geometry Valve Enclosure On 36" NB Pipe

North Sea Transmission Line

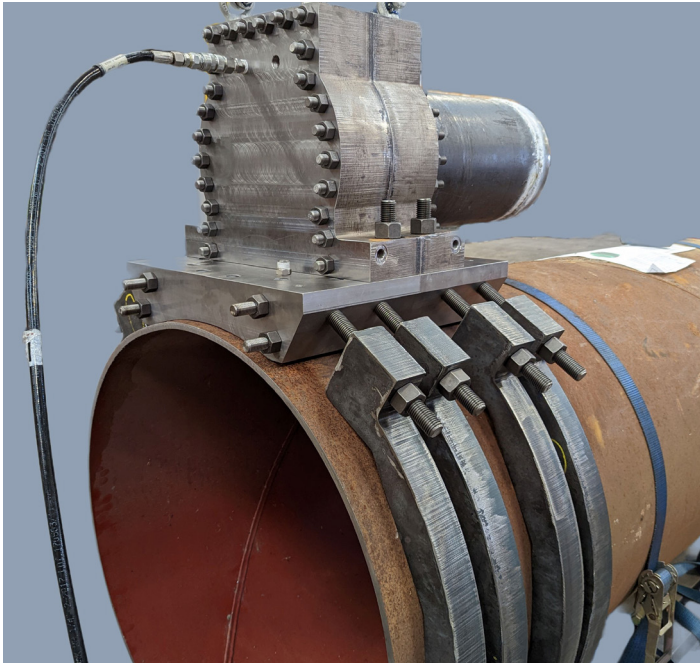
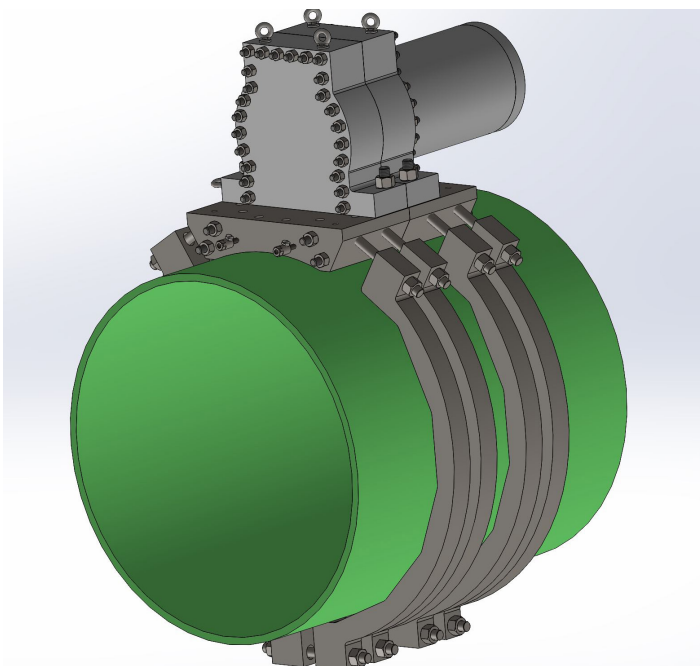
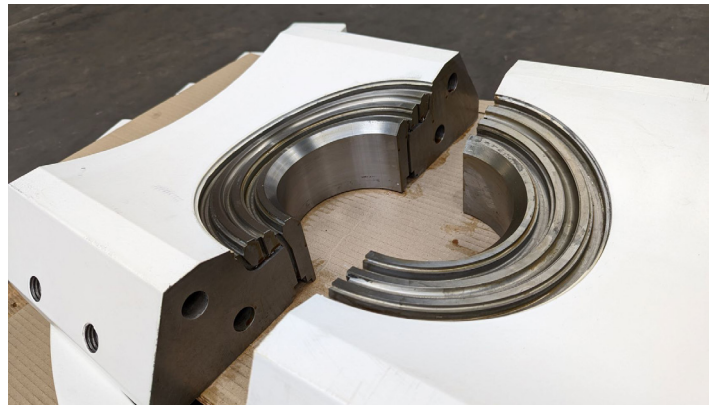
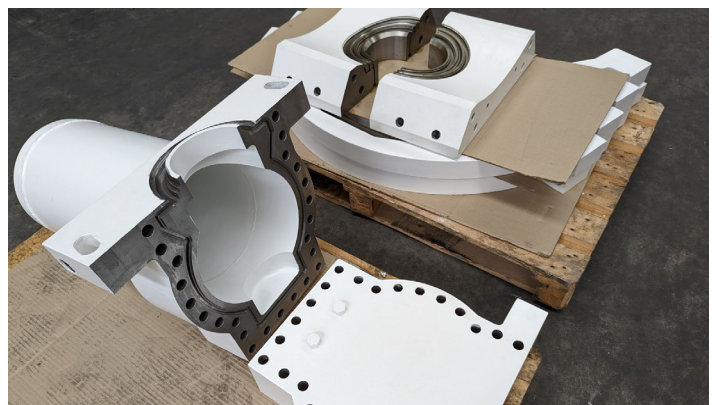
The mechanical clamp was designed to encapsulate the valve using a saddle and strongback assembly. The multi-part design enabled the clamp to enclose the valve, regardless of what position it was found to be in once excavated. 5-axis machined seal grooves were provided to ensure a reliable seal against the main 36" NB pipe, whilst keeping the size and weight of the solution as low as possible.

Design fully pressure tested in-house prior to shipping to client.
