Technowrap™ Engineered Composite Repairs - 2K LT

18" Carbon Steel Quick Response Repair

EDF Energy

April 2022

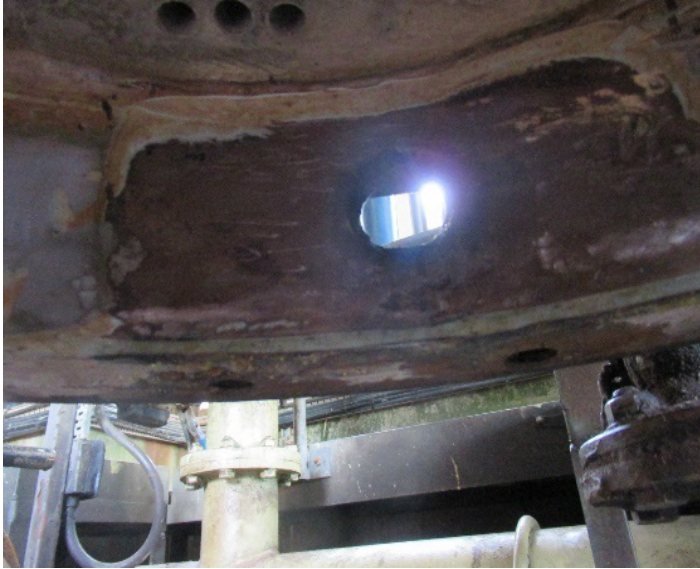
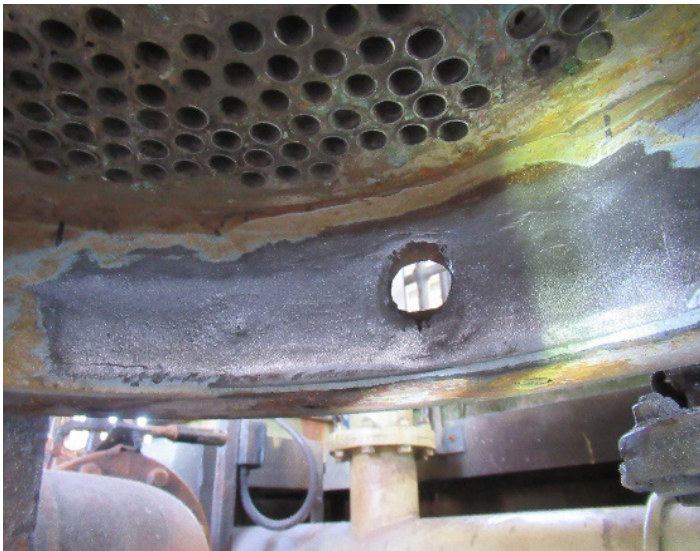
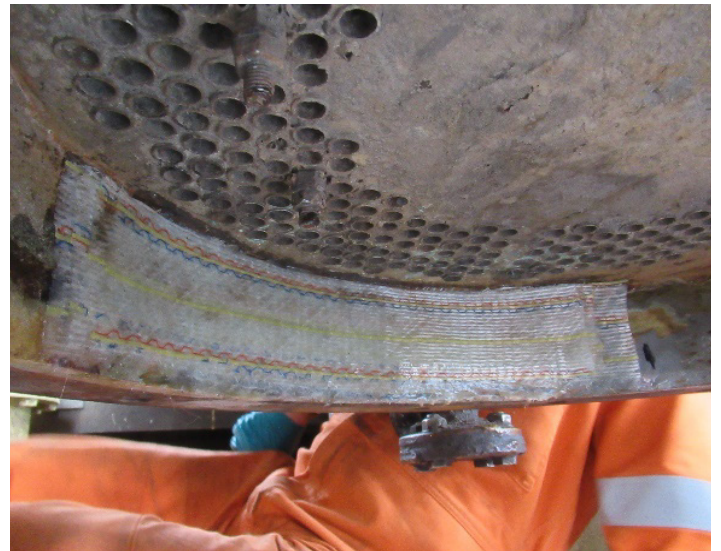
EDF Emergent requested out of hours on Bank Holiday Monday 18" Carbon Steel Gen TX 2 Spare Oil Conservator which was suffering from a through-wall defect due to external corrosion of the weld. This repair was subsequently designed for a through-wall defect.

ICR were onsite the following day, with an engineered repair solution of 8 layers of Technowrap™ 2K LT was delivered to restore the integrity for a design life of 15-years.

- Technicians onsite within 24 hours, installation was delivered, QA/QC checked and handed back to site in a 3 day window
- 15 year Design life
