## Technowrap™ Engineered Composite Repairs - 2K LT

# Carbon Steel 20" Condensate Pipework Repair

**Client**  
EDF

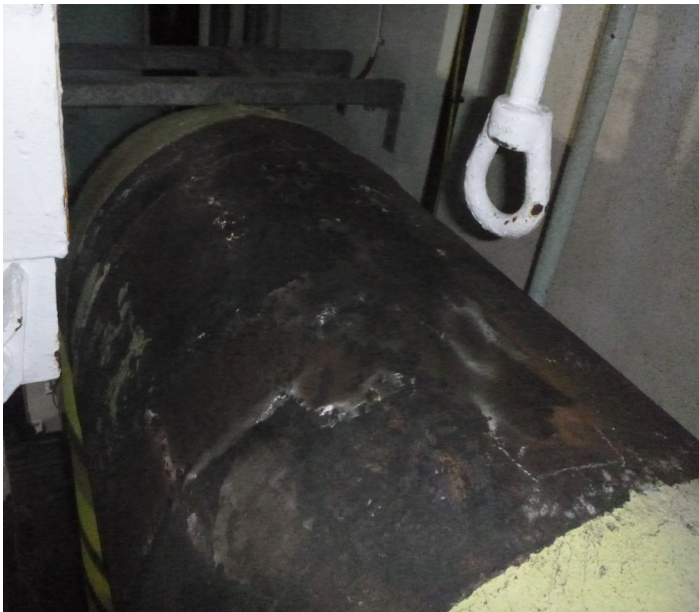
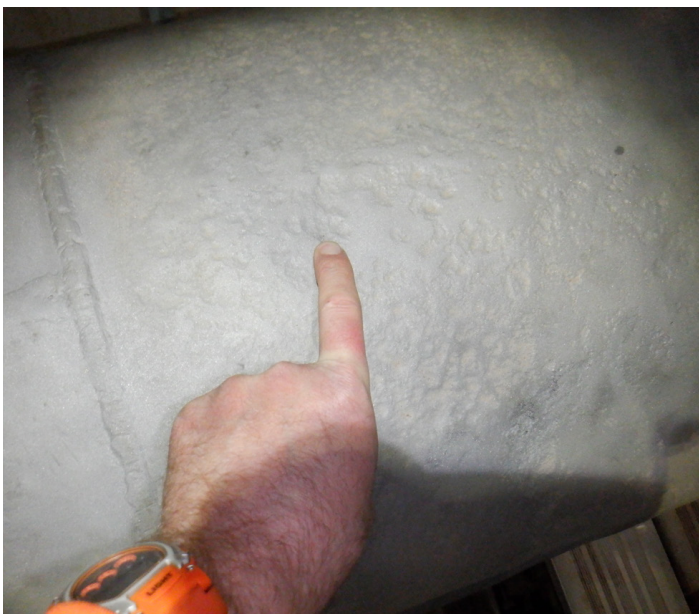
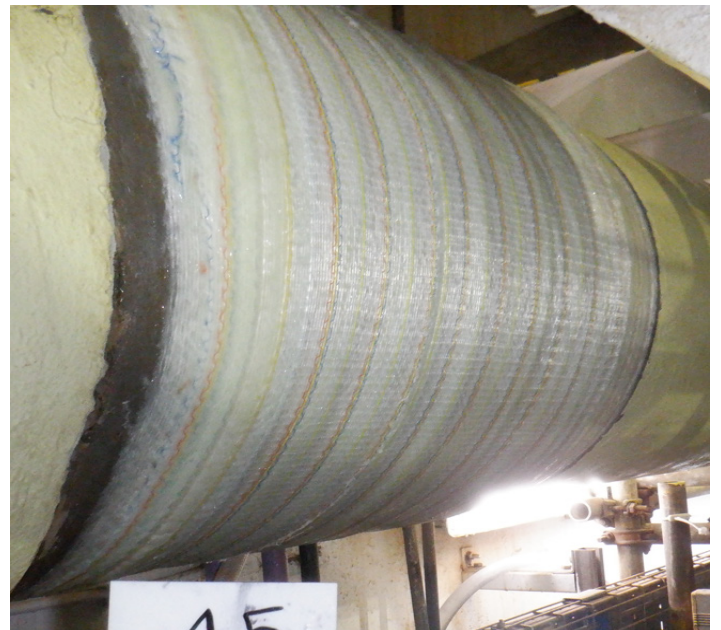
EDF Carbon Steel 20" Condensate Pipework Repair Water Line (TG2-20" Condensate Return). The line was suffering from a through wall defect caused by external corrosion.

ICR were requested to provide an engineered repair solution to restore the integrity of the line for a design life of 5 years. This repair is subsequently designed for a through-wall defect

- Engineering design calculation complete with design sketch, materials and manpower to complete the 15-layer repair using the Technowrap™ 2K cloth with the Technowrap™ LT resin.
- No hot work required
- Defined life repair of 5 years
